Addendum to the Response Action Work Plan Former Stimson Central Maintenance Building Removal Plan 875 Highway 2 South

1.0 Introduction

This removal work plan is an addendum to the Response Action Work Plan (RAWP) (CDM 2003) and details specific information regarding removal activities that will take place at the Former Stimson Lumber Central Maintenance building, 875 Highway 2 South.

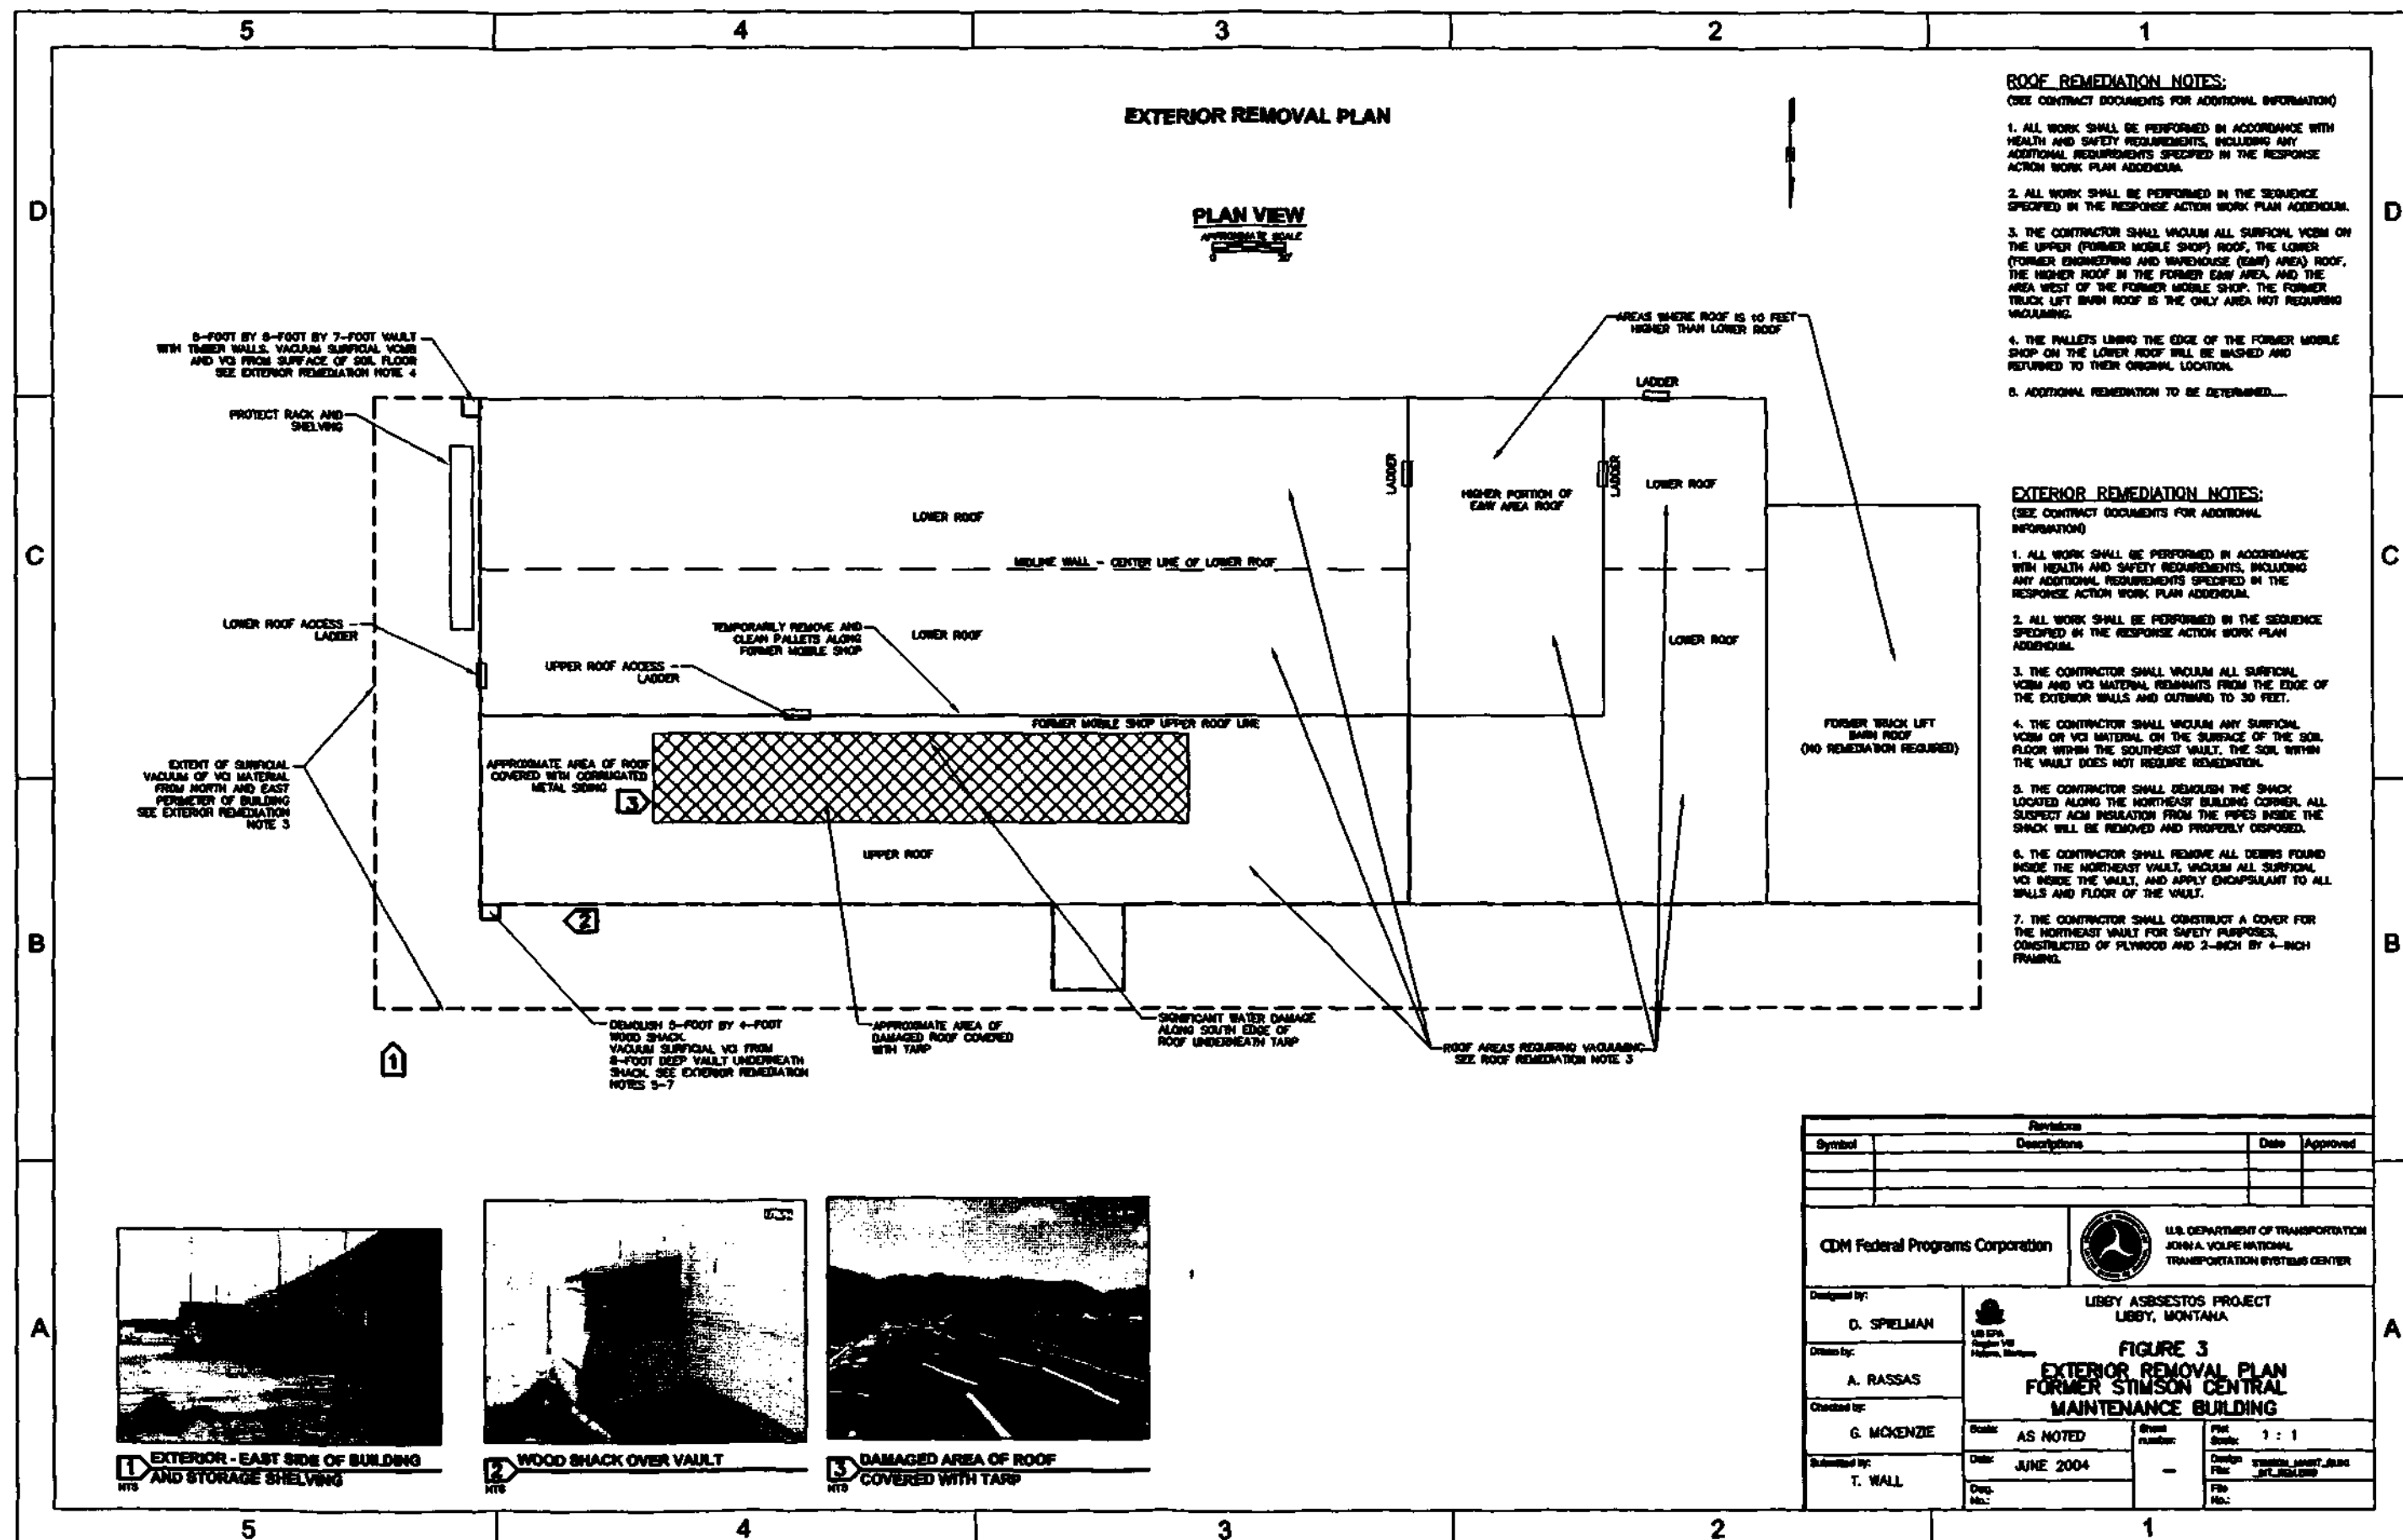
| Designed by: | D. SPIELMAN | LIBBY ASBESTOS PROJECT LIBBY, MONTANA FIGURE 3 EXTERIOR REMOVAL PLAN FORMER STIMSON CENTRAL MAINTENANCE BUILDING | |

- The roof of the Former Mobile Shop has significant damage; the tar paper has been removed or damaged on about 30% of the roof, confined mostly to the south and east areas of the roof. This area has been covered with a tarp (see Figure 3). Inspection of the roof under the tarp revealed that most of the aerated concrete is intact, with the exception of about one-third of the material which is severely degraded and wet. The damaged material is concentrated in the south side of the repaired area.

- The roof of the Former E&W Area B and the raised E&W area roof do not contain aerated concrete VCBM.
- The entire roof of the Former E&W Area (lower roof) is undamaged and in good condition.

- VCI and VCBM debris is present on all roof areas, with the exception of the Former Lift Truck Barn roof.
- All areas of the roof can be accessed by ladders. Locations are shown on Figure 3.

- The upper (Former Mobile Shop) roof will be surface vacuumed to remove VCBM debris. The cleanup/construction contractor may use mechanical means, as necessary, to loosen the dirt and debris, while implementing dust suppression.

- The damaged tar paper will be removed and properly disposed.

- The following roof areas will be surface vacuumed after the completion of the upper roof: entire lower (Former E&W Area) roof including the roof area west of the upper roof and the raised roof area that is approximately 10 feet higher than the lower roof area. See Figure 3 for locations. Mechanical means may be used in these areas as well. The only roof area not requiring vacuuming is the Former Lift Truck Barn roof.
